Glass Breakage - Nickel Sulphide Inclusions

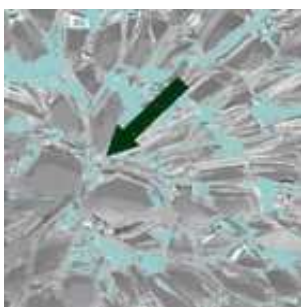
Figure 3: Fracture pattern due to NiS, with fracture origin indicated by the green arrow (Source: Barry 2006, permission requested)

Another aspect of nickel sulphide failure is the fact that these failures rarely occur upon installation or even within the first few months following installation. Nickel sulphide failures produce a fracture pattern that is often referred to as a “double D” or a “butterfly” pattern, as shown in Figure 3 (Bowler-Reed 2002, Barry 2006). This is easily recognizable if the fractured glass is recovered more or less intact. However, if the glass is at all disturbed upon breaking or the

fracture origin is not recovered, the breakage pattern can be mistaken for an edge damage failure, and an edge damage failure can be mistaken for a NiS failure. Therefore, the statistics on when these failures occur is not as reliable as they could be.

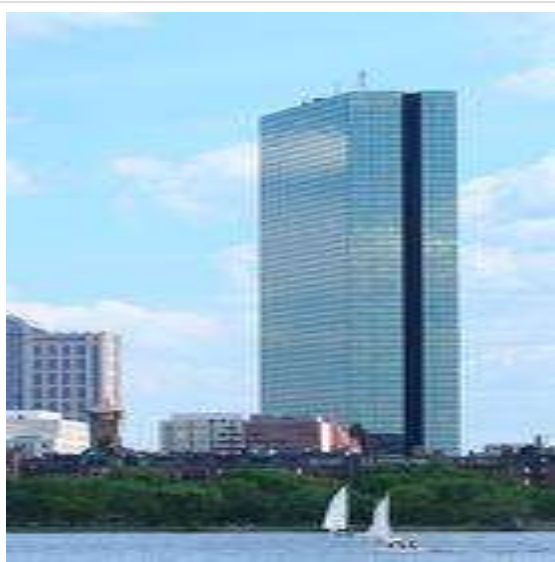
Figure 5: Image of the John Hancock Tower in Boston, MA, USA

The most well-known failure of windows on the Hancock Tower, located in Boston, MA in the USA, is commonly attributed to the bond layer material. Some originally attributed to nickel sulphide inclusions, although this was later disproved. (Johnson 2008). The failure began in 1972, while the building was still under construction, but it became especially significant during a wind storm in January of 1973. The bond material created too strong of a connection,

leading to pieces of the glass being pulled off the pane at the glass-bond layer interface. Glass is ill-equipped to cope with the stress increases associated with this edge damage, and therefore underwent spontaneous failure of the glass. Following the discovery of this issue, all 10,344 glass panels on the building were replaced with tempered glass at a very high cost (estimated to be \$5-7 million at the time of the replacement). Much less known is that some of these replacement panels suffered from nickel sulphide failure (Schwartz 2001). An exact number of panels that failed as a result of NiS were unable to be determined.

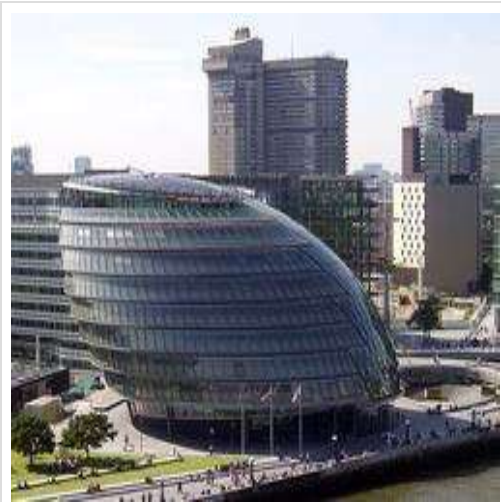
Figure 6: Image of the Foster & Partner's City Hall in London, England

Foster & Partner's City Hall is located in London, England. It was likely affected by nickel sulphide failure in 2004, when several floor-to-ceiling panels of tempered glass on the interior of the building spontaneously shattered (Arnold 2004). The glass had not been heat soaked prior to installation. At the time of the publication of the Arnold article in which this information was found, an official investigation was in progress, and the preliminary findings pointed to nickel sulphide. This author was unable to find any record of the final cause determined.

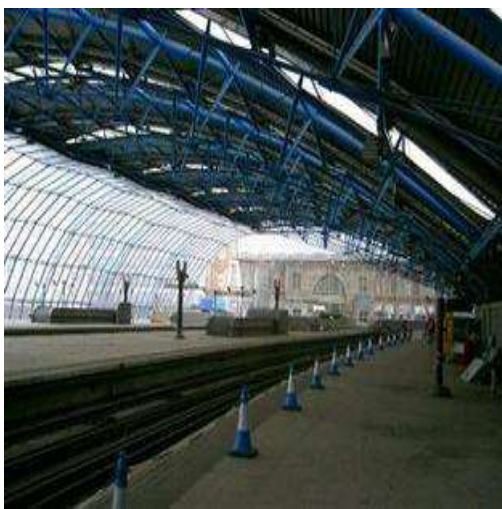
Figure 7: Image of Waterloo International Rail Terminal in London, England

This case was mentioned in passing in the article regarding the Western Morning News Building (discussed below). The two buildings were designed by the same architect, and the article therefore tries to connect the issues experienced on the buildings. The Waterloo International Rail Terminal is located in London, England. All that was said in the article was that it experienced glass failure due to nickel sulphide in 1999 (Booth 2002).
